## Memorandum

From: Rachel A. Zancanella, P.E., Division 2 Engineer

Subject: Bartlett Gulch, Twin Lakes Ditch Drainage, and Barn Pond Site Visit Determination  
July 9, 2024 Site Visit

Date: August 5, 2024

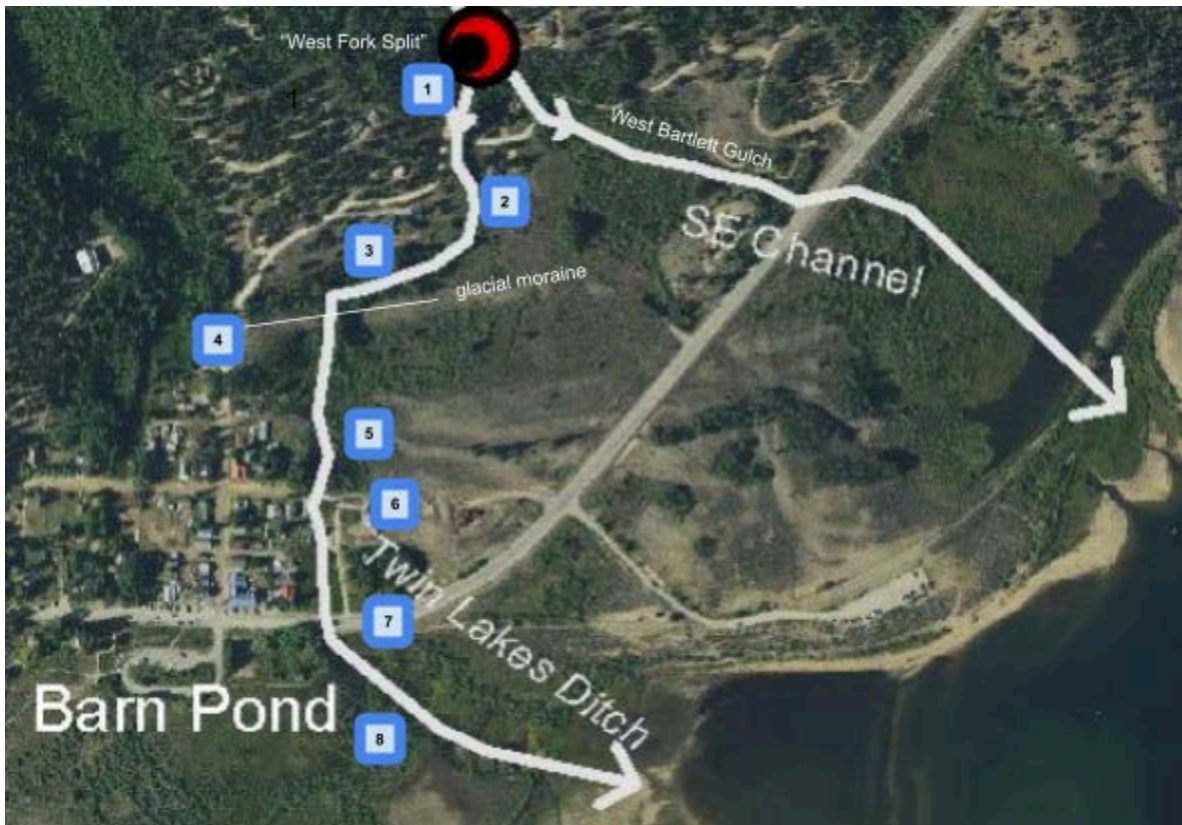
The drainage on Figure 5 labeled “Twin Lakes Ditch” was inspected from the split off of West Bartlett Gulch labeled “West Fork Split” in a southerly direction to the Barn Pond (see enlarged area in Figure 6). The numbered points/areas in Figure 6 correspond to a pictorial log of observations of the physical attributes of the channel as it runs through the Town of Twin Lakes. These areas are described in further detail below.

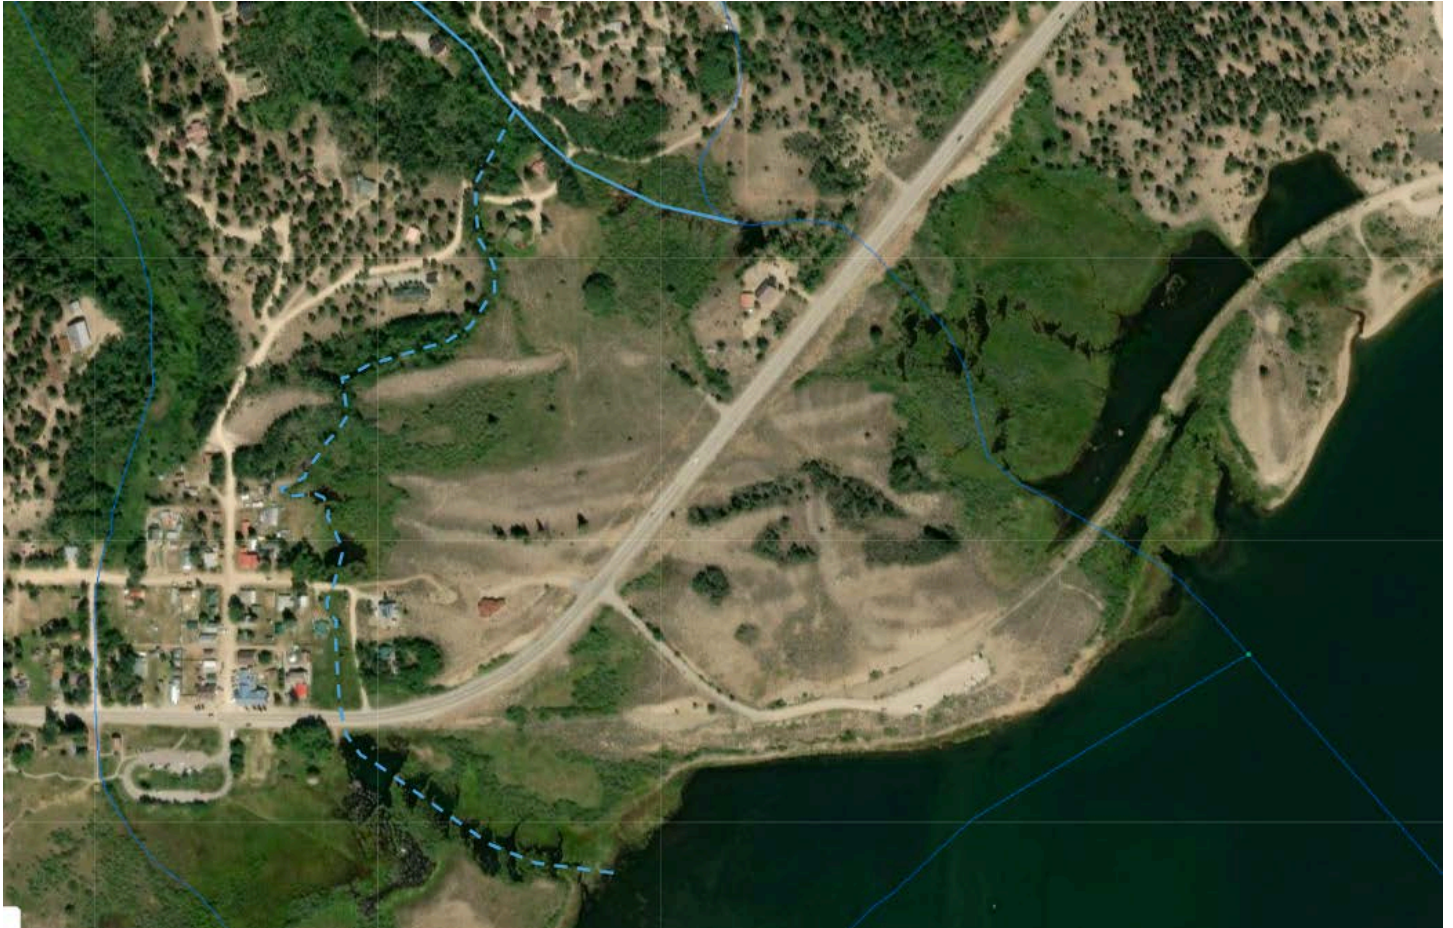
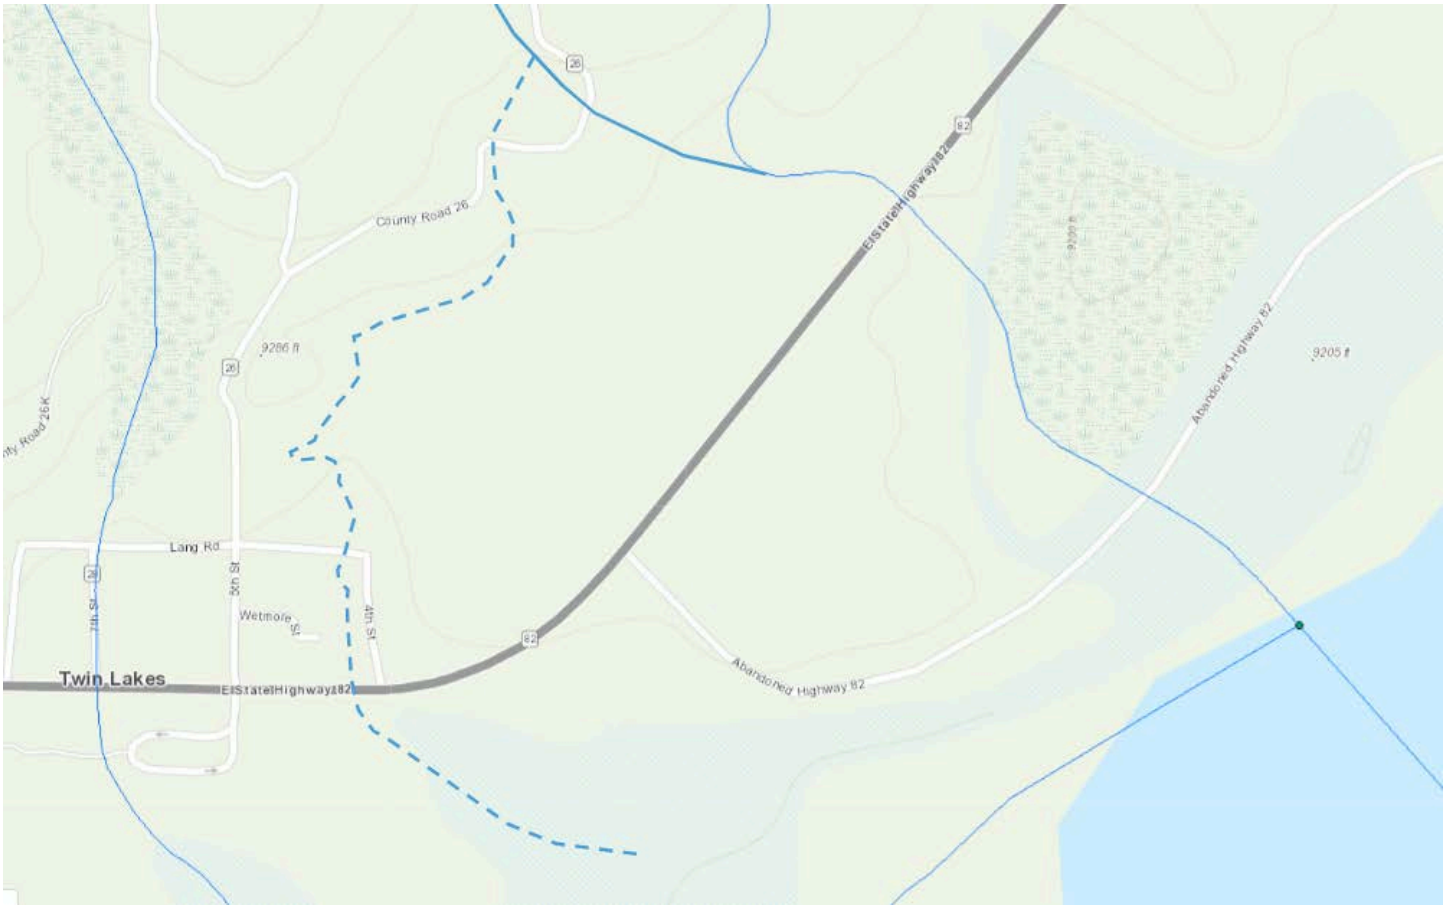
At Point 1 (West Fork Split) “Twin Lakes Ditch” took off from the point of diversion and immediately followed a U shaped path that runs parallel to the contours whereas West Bartlett Gulch continues straight in a manner that runs perpendicular to the contours.

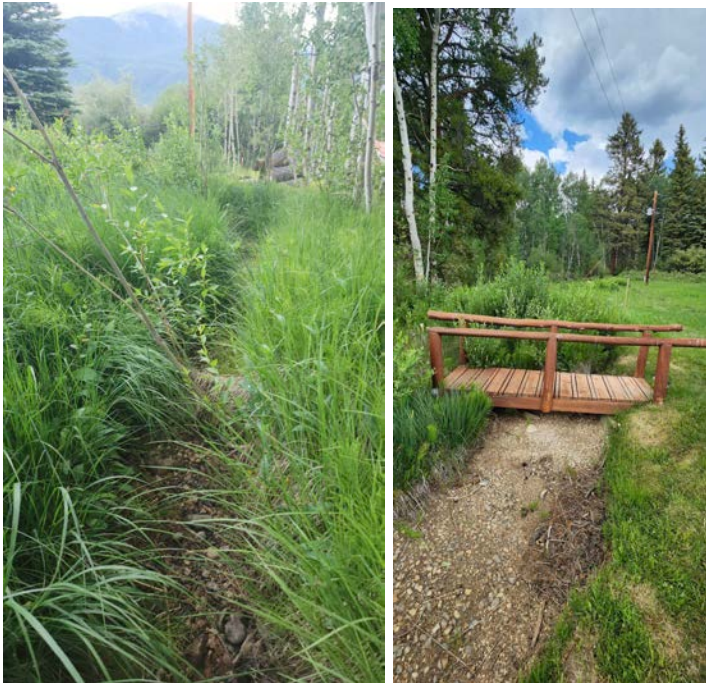
Figure 9. Area 1 U shaped ditch just down ditch of the “West Fork Split”

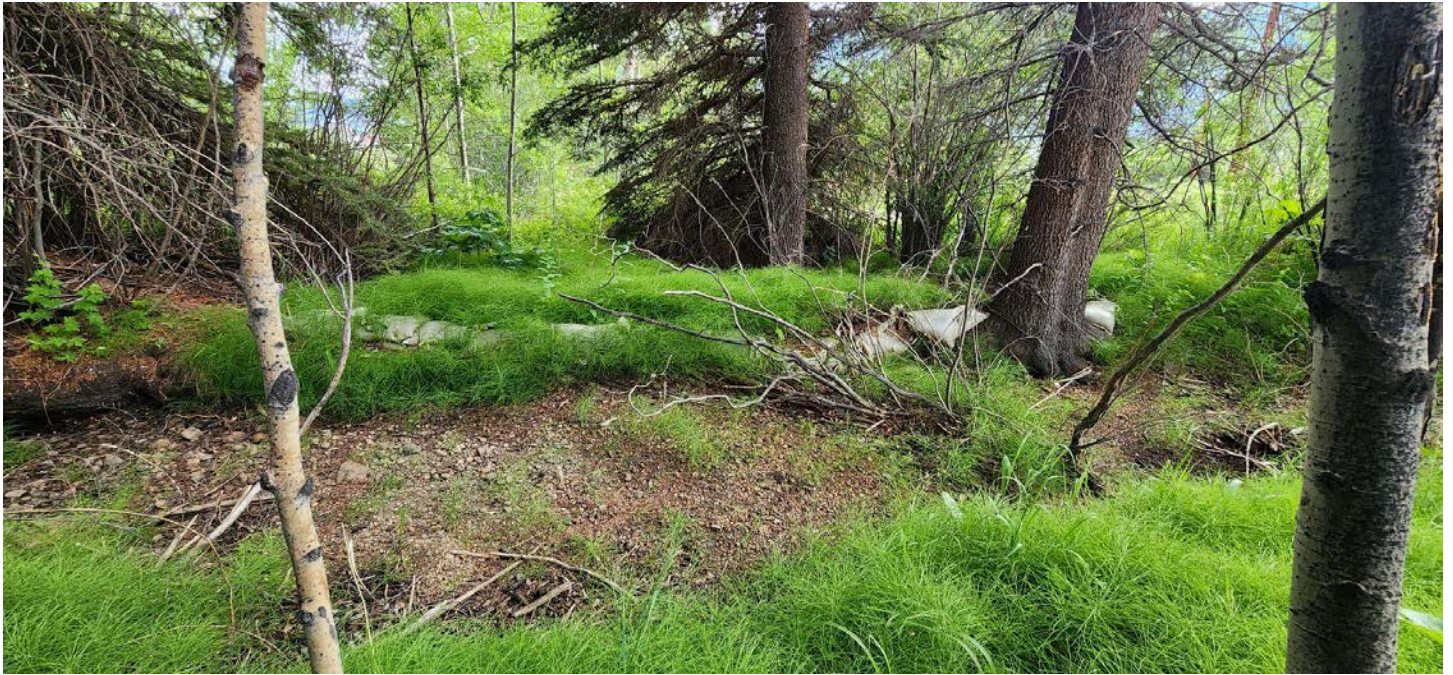
**Area 2** After the channel diverges from West Bartlet Gulch, it flows parallel to the contours towards Dayton Gulch.

Figure 10. Area 2 photo taken at the apex of the curve (Point 2) facing down gradient, channel flowing left to right parallel to the grade.

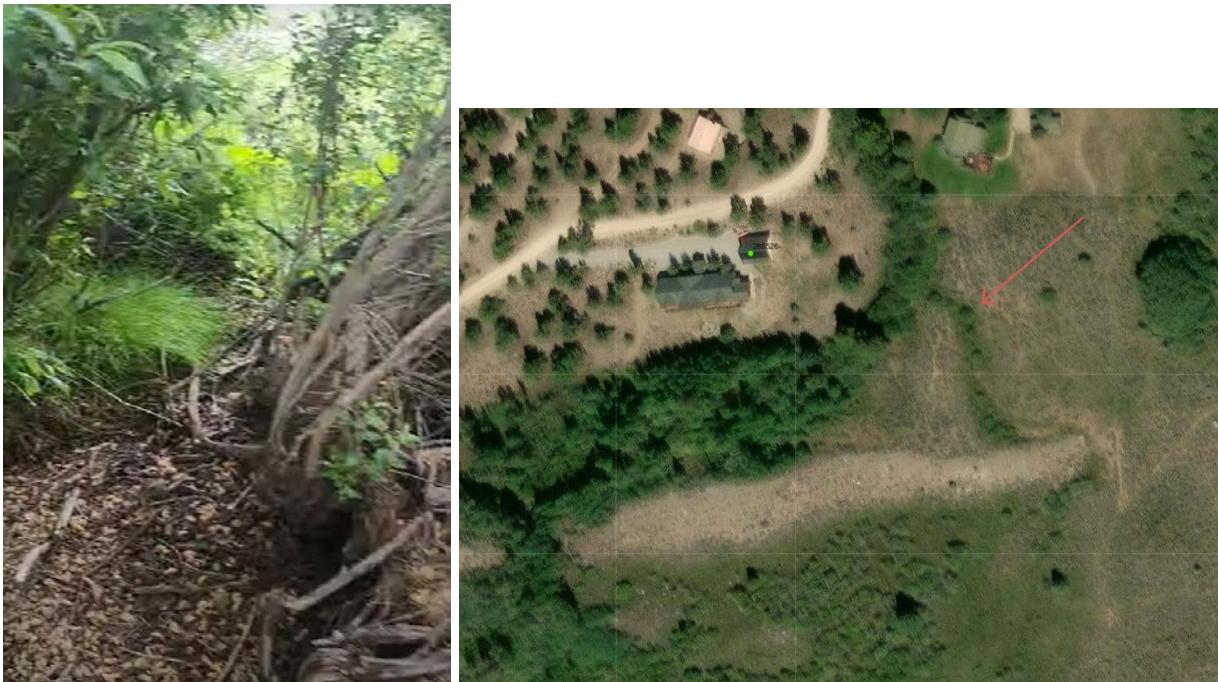
**Area 2** Also in Area 2, water appears to have breached the channel and follows a route back towards the east perpendicular to the contour and ultimately flows to the east before changing direction again and rejoining the flow near Marcum's pond after turning into a separate drainage.

Figure 11. Area 2 photo taken of breach in the channel and aerial view of breached channel.

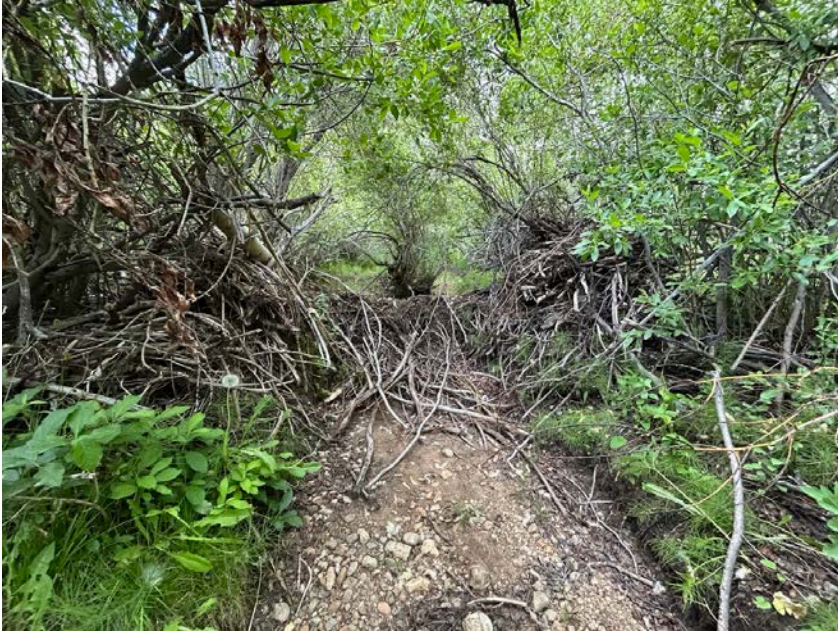
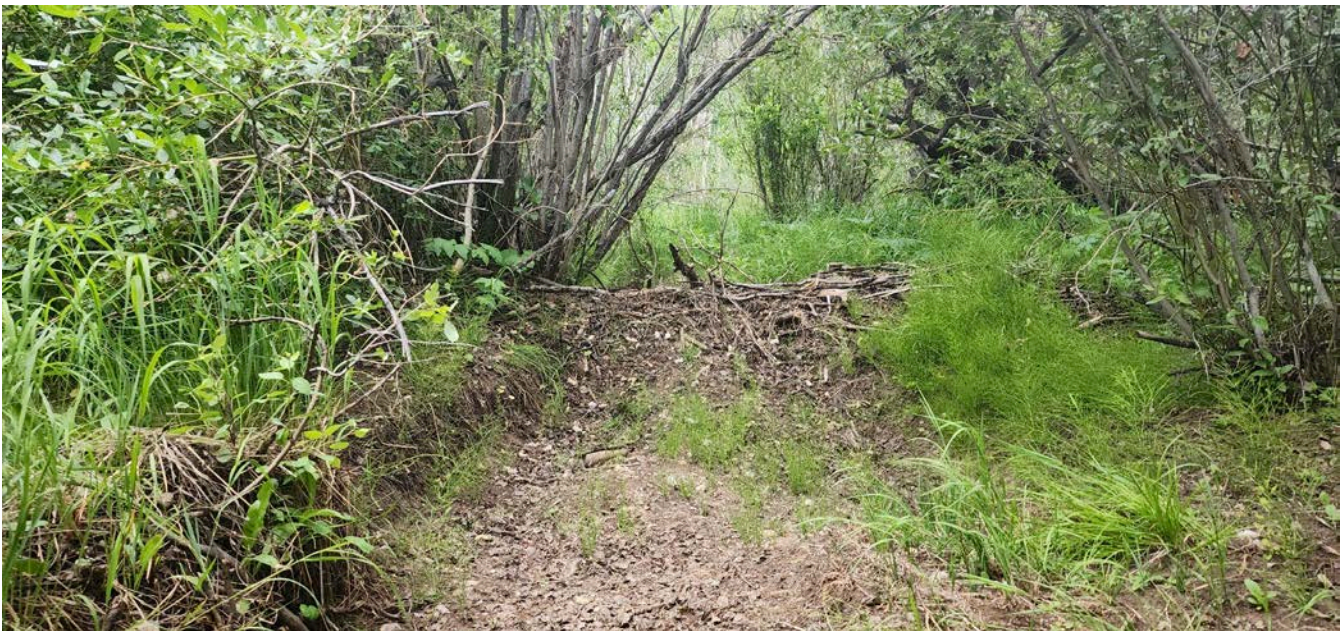
**Area 3:** The channel parallels the “glacial moraine”, a geologic formation that acts like a giant berm and runs east to west upgradient from the Town. Through this area, the grade of the channel is very flat and is blocked at multiple points by small beaver dams creating an obstructed path causing water to back up, infiltrate and evaporate along the route.

Figure 12. Area 3 photos taken of beaver dams in channel.

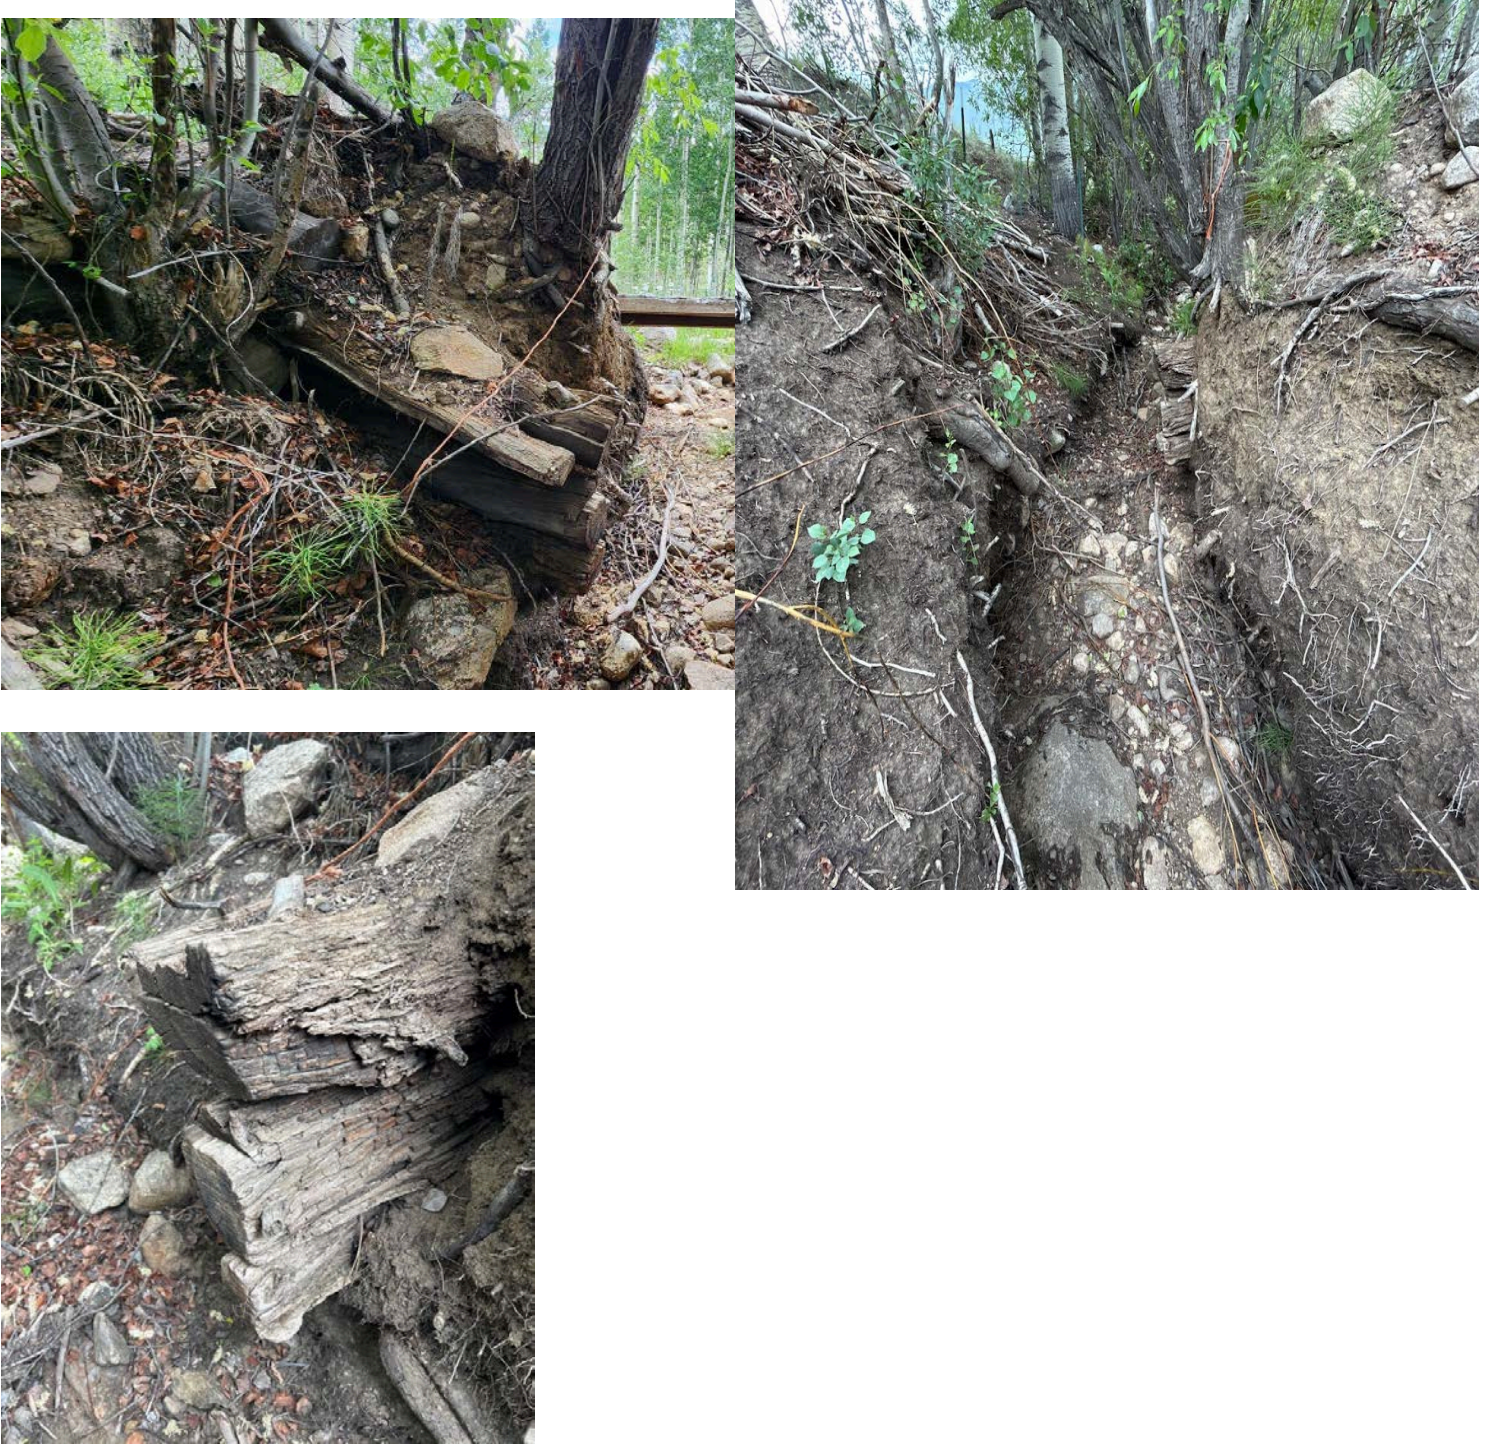
In between points 3 and 4 on Figure 6, the channel takes an almost 90 degree turn to the south through a hand cut section in the “glacial moraine” and enters a natural drainage located in between Dayton Gulch to the West and West Bartlett Gulch to the East. Inside the cut section of the berm are old, hand cut timbers buried within the embankment which resembles construction methods of dams from the early 1900’s.

Figure 13. Area 3 photos of excavated cut through “glacial moraine”.

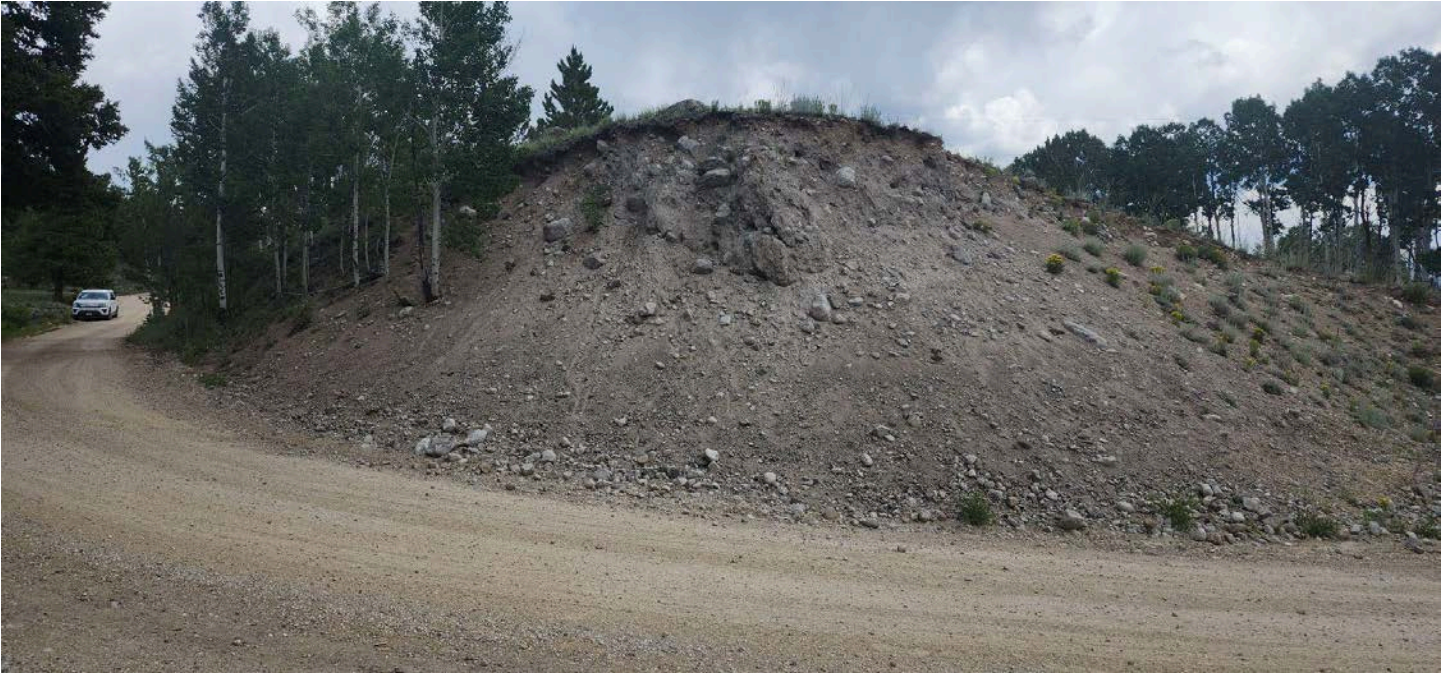
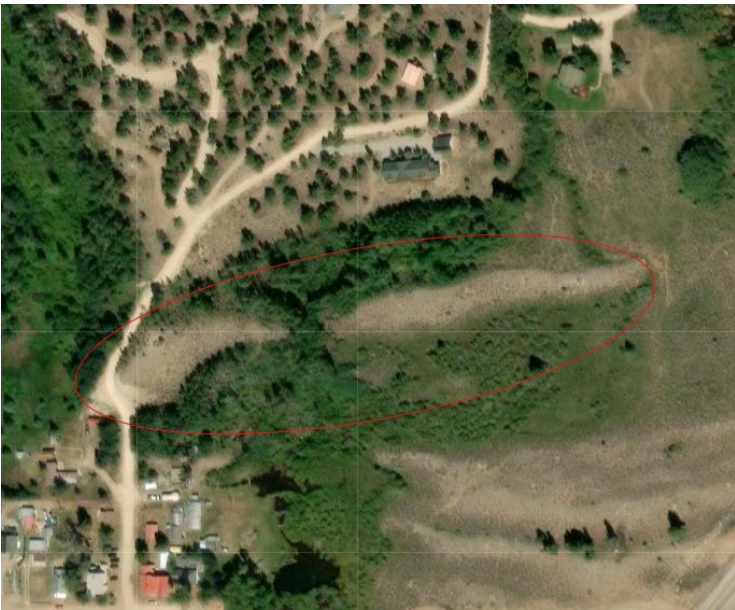
Area 4: Cross sectional view of the west end of the “glacial moraine” on County Road 26 and aerial view of glacial moraine.

Figure 14. Area 3 “glacial moraine”.

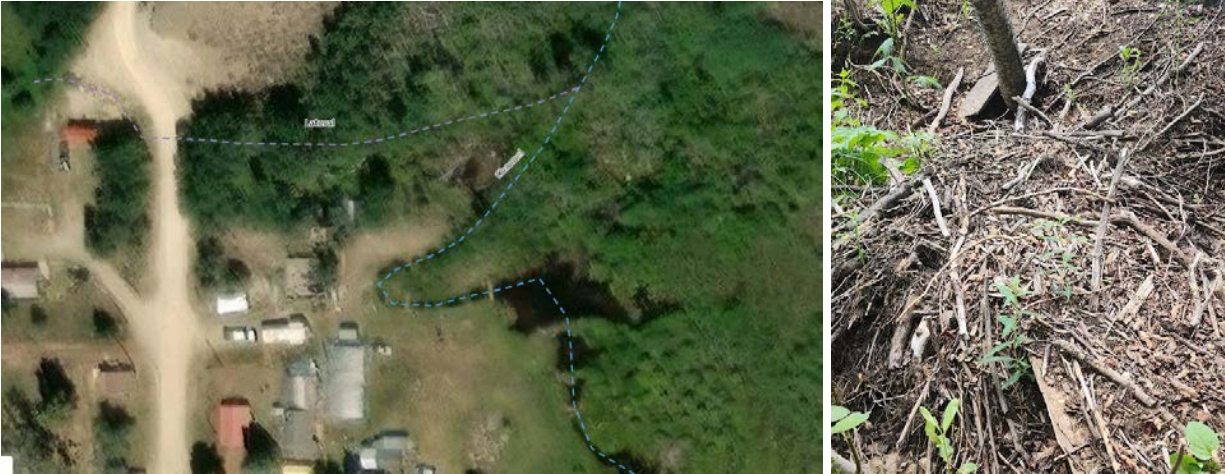
In between Area 4 and Area 5 on the channel, we observed a diversion structure which took off to the West in a small lateral, crossed under 5th Street and ultimately terminated into Dayton Gulch.

Figure 15. Path of lateral and diversion structure off the channel.

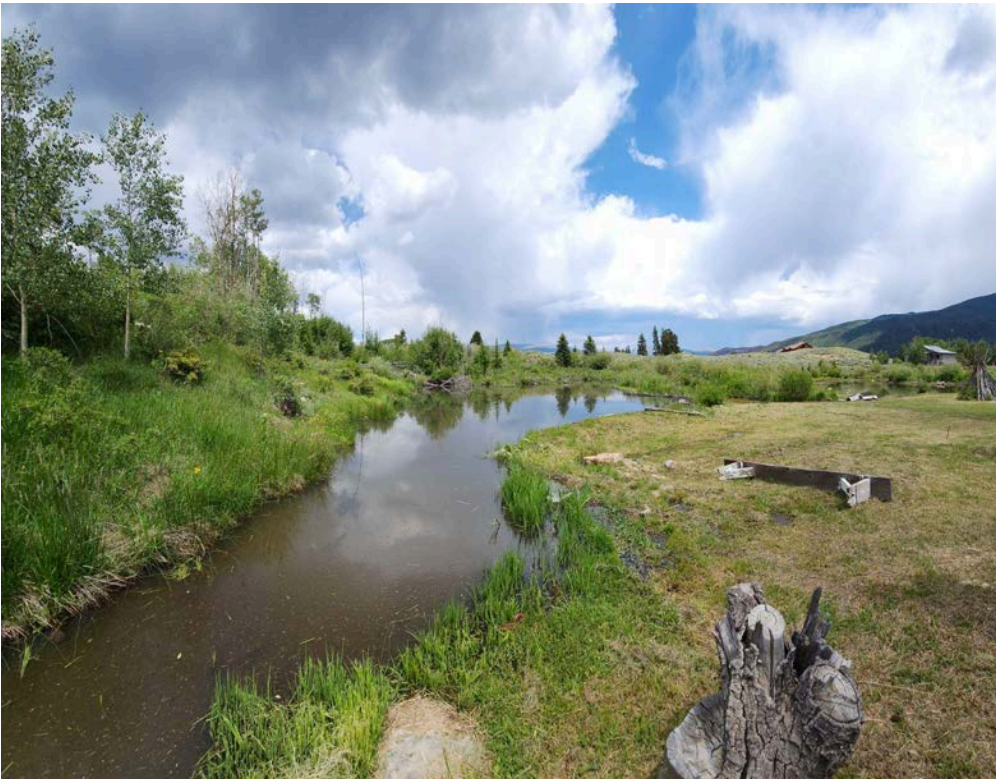
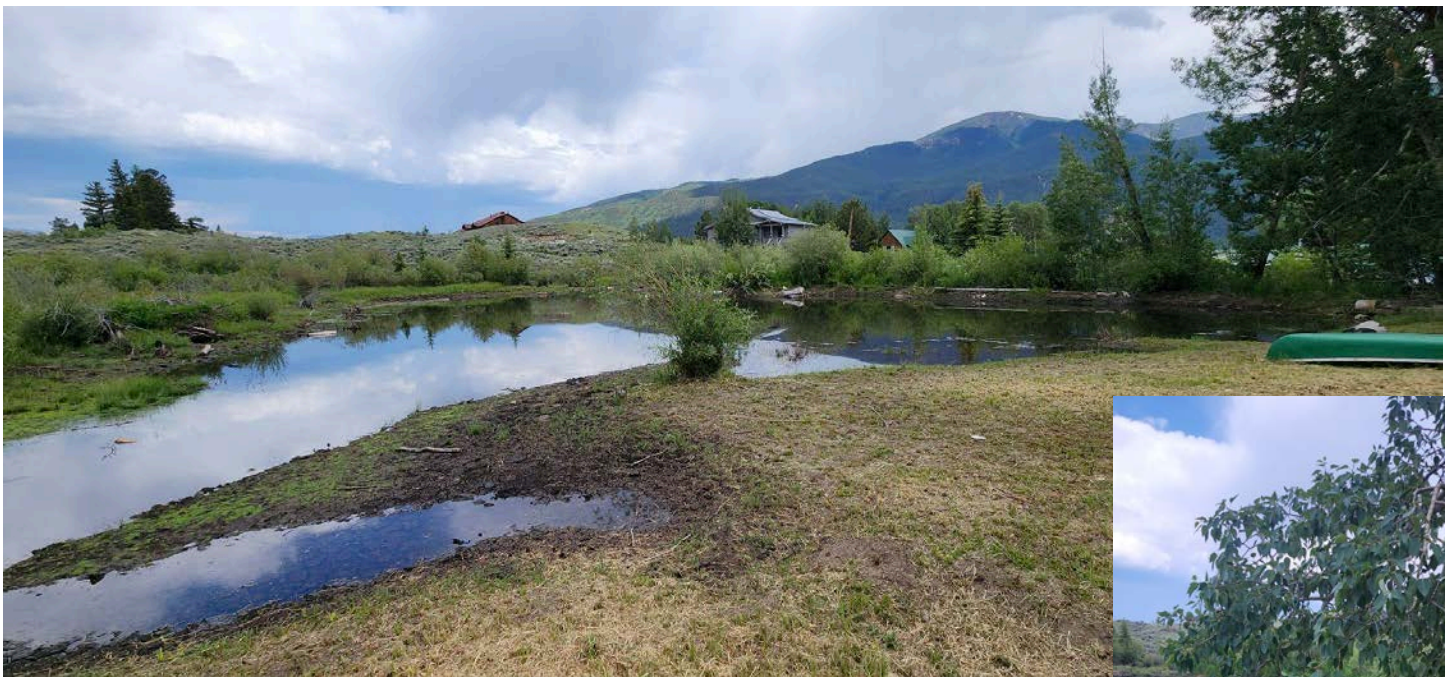
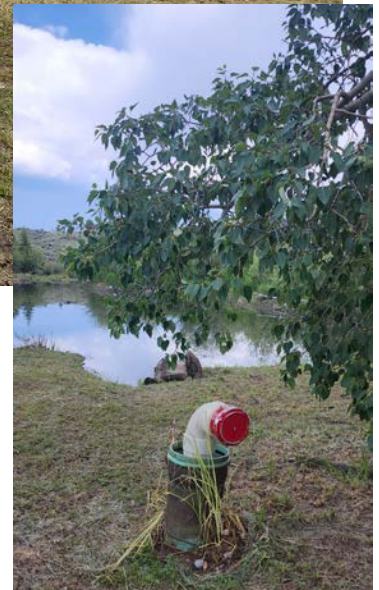
Figure 16. Marcum Beaver Ponds.

Area 5 Marcum's Beaver Ponds including fire hydrant diversion structure.

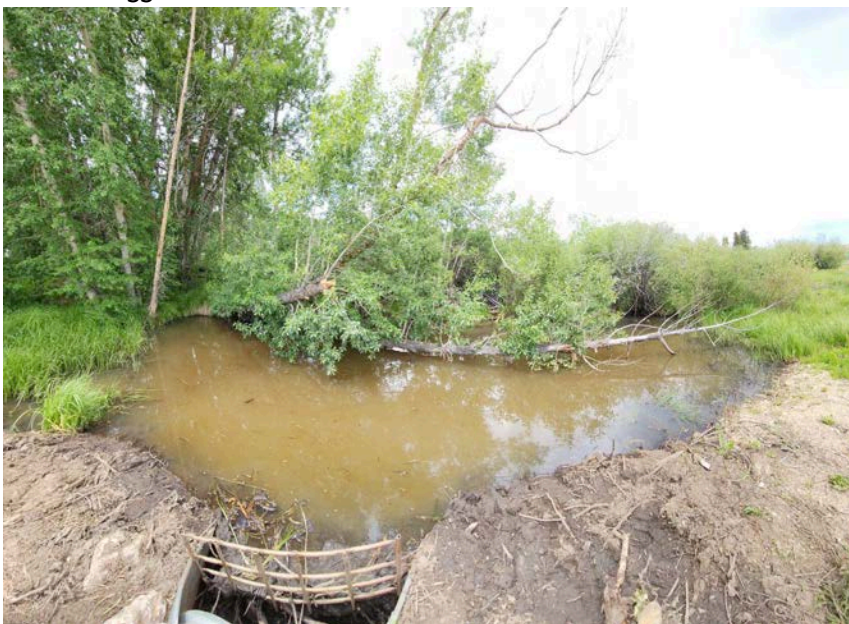
**Area 6 Clogged culvert down ditch of Marcum's Beaver Ponds on the north side of Lang Road**

Figure 17. View looking upstream towards Marcum Beaver Ponds.

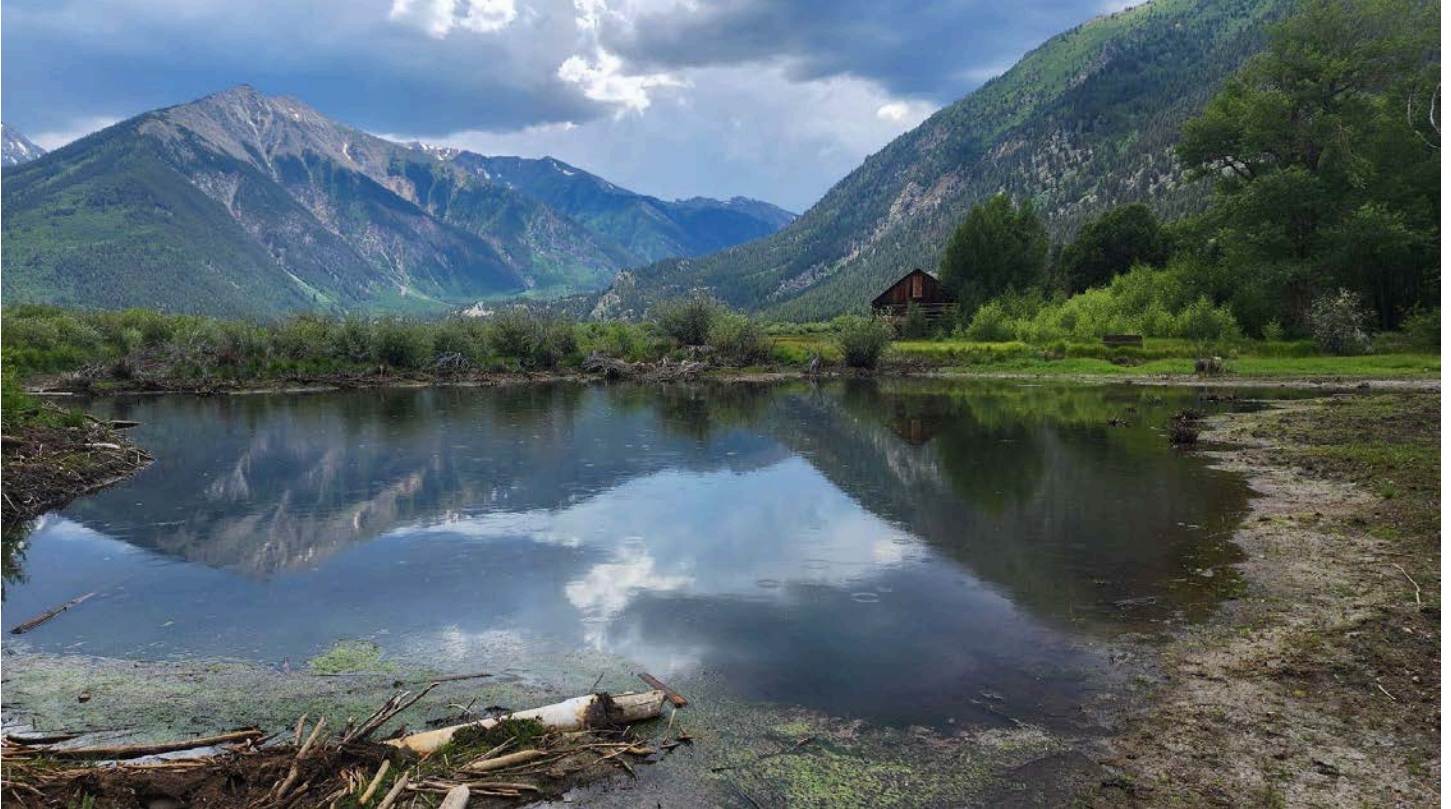
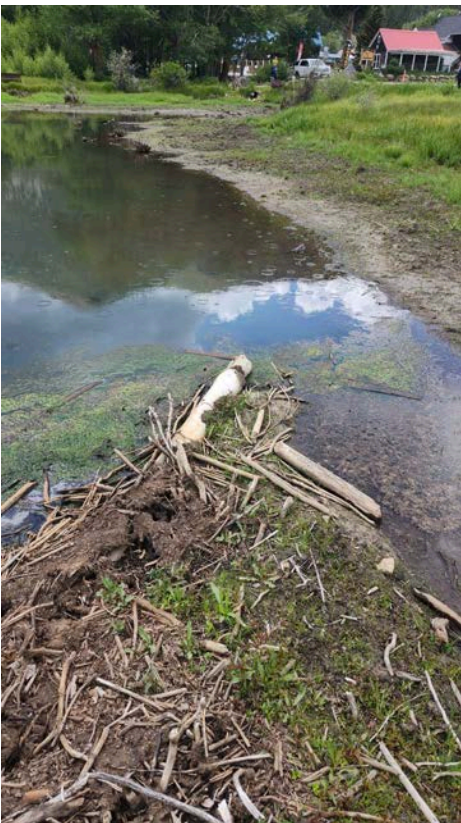
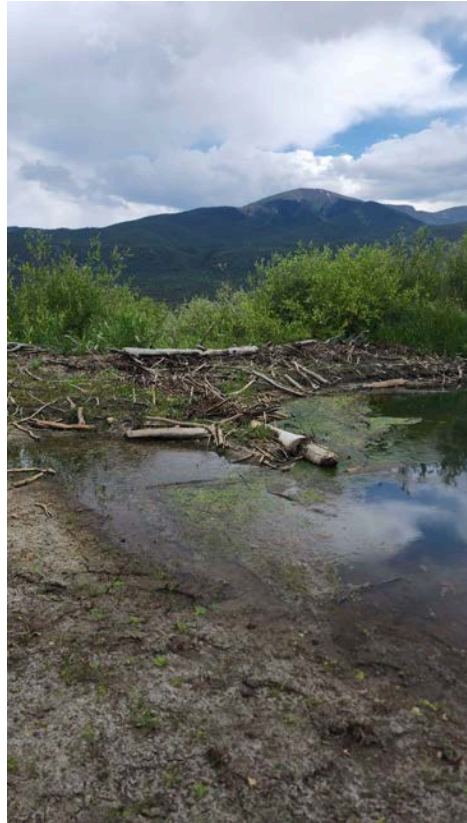
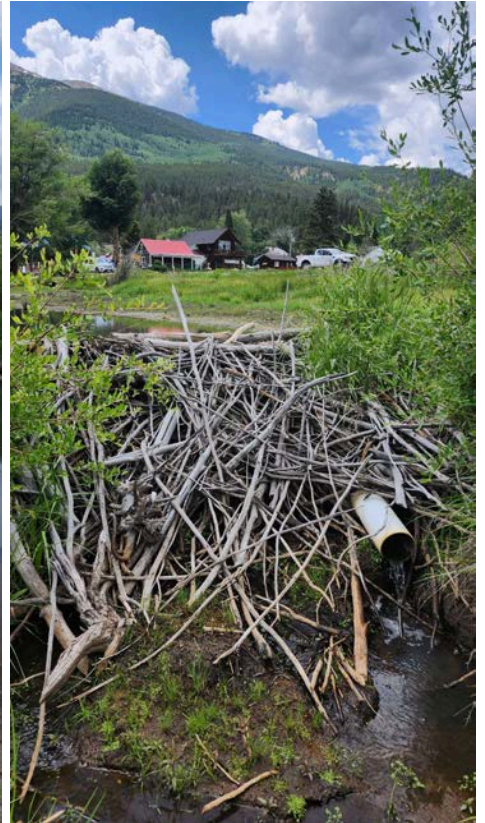
Area 7 & 8 Barn Pond and dam, including “beaver deceiver” which was plugged by a log at the time of the inspection.

Figure 18. View of “Barn Pond”.

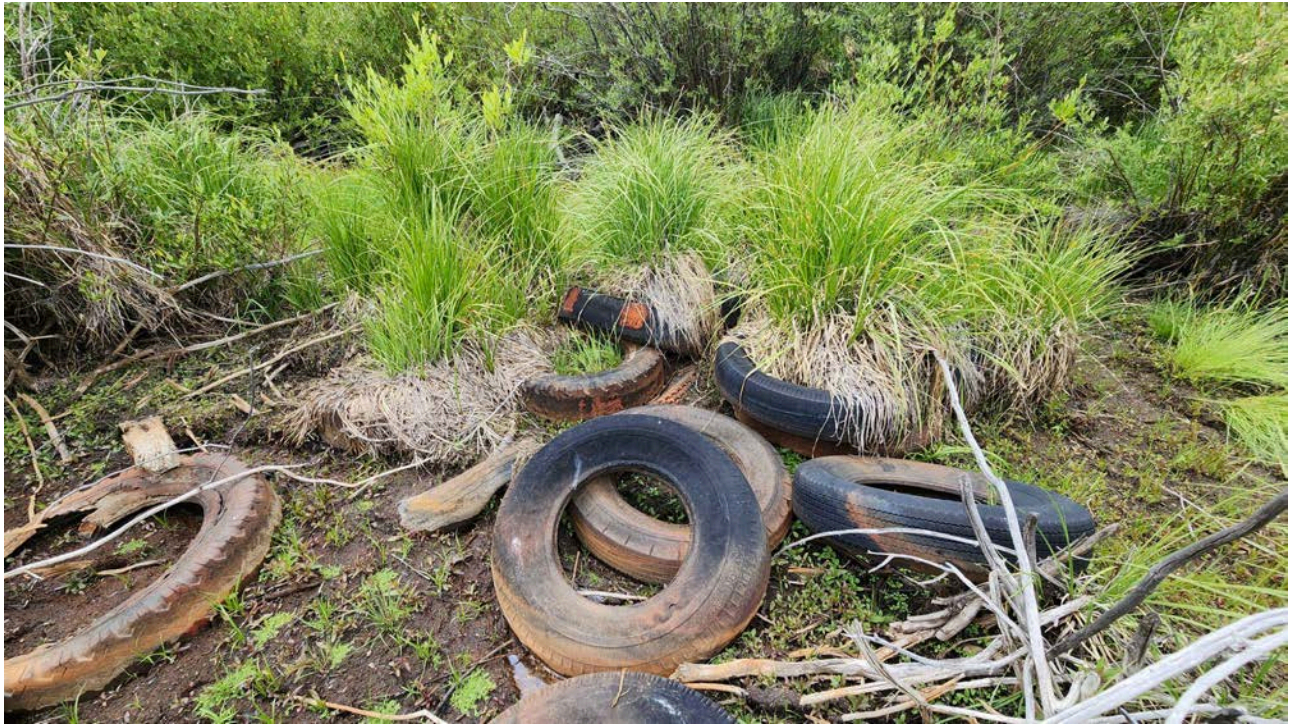
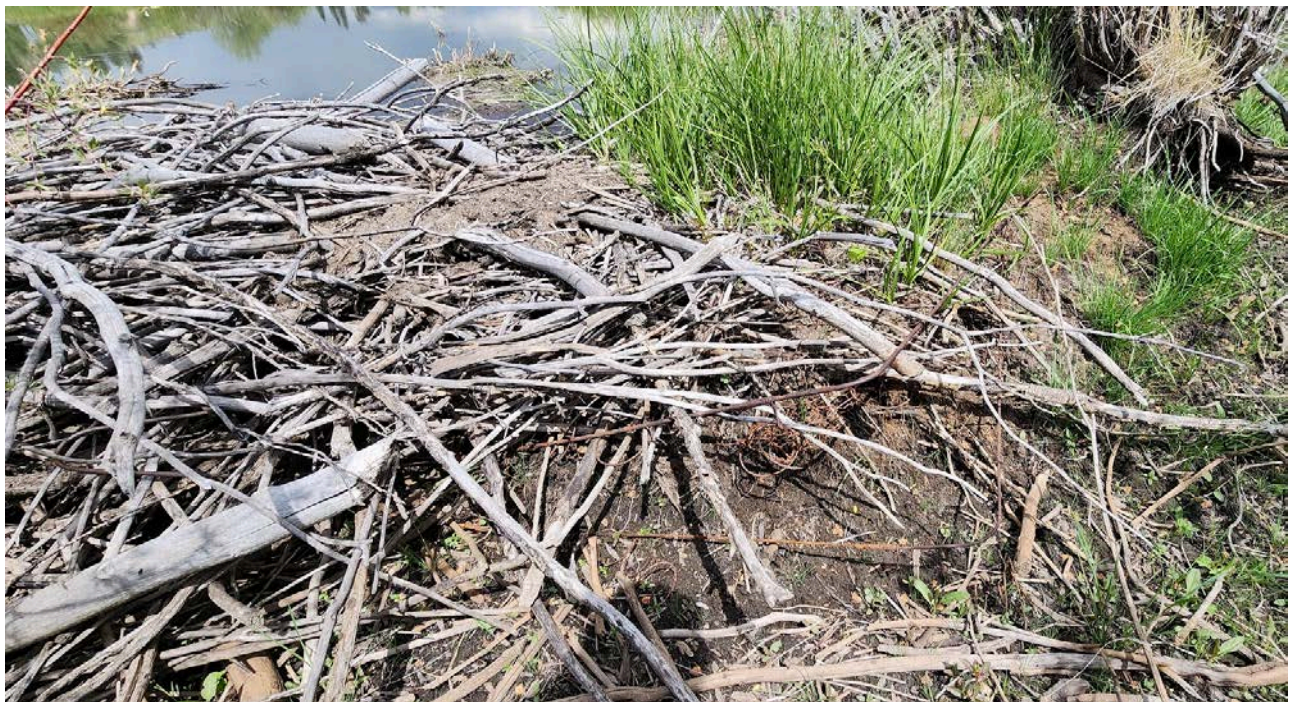
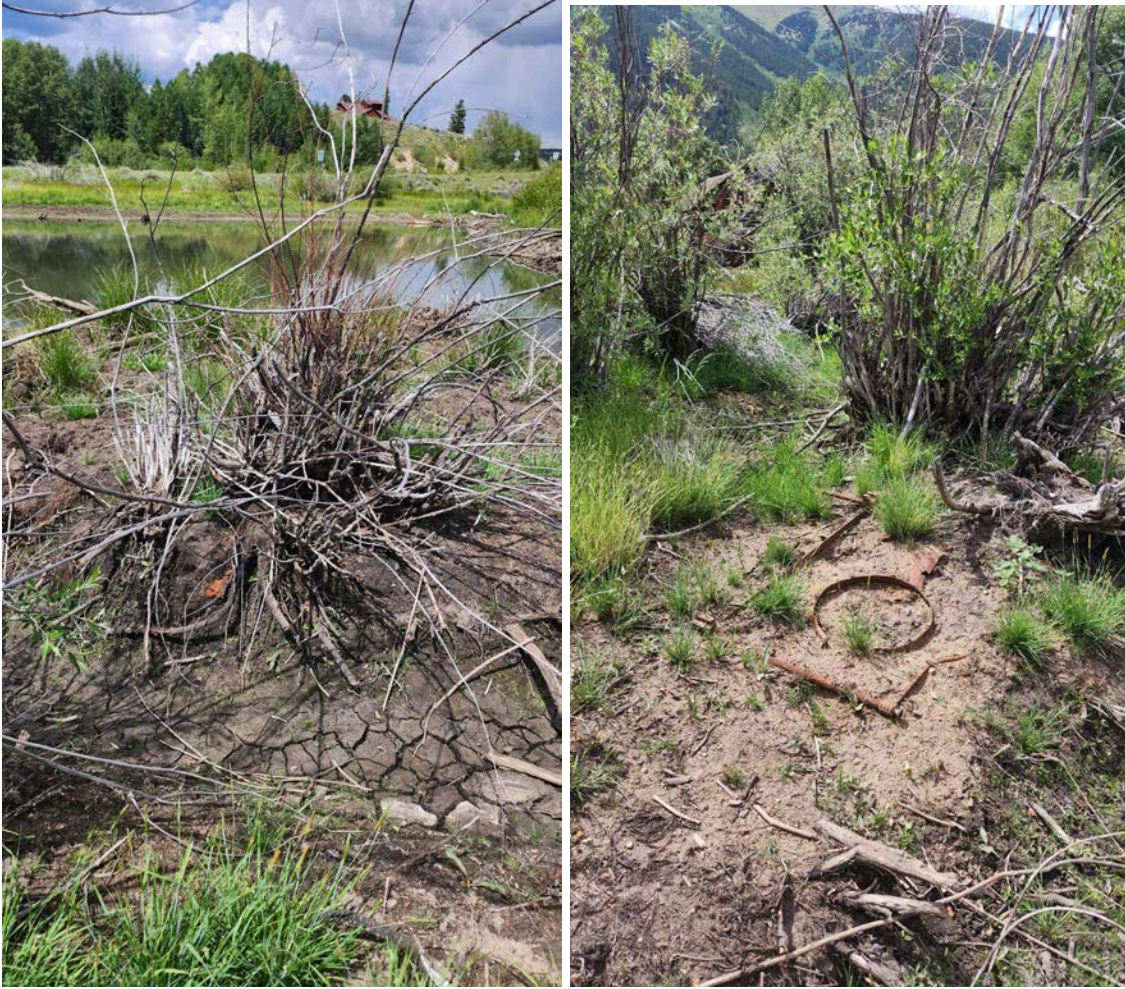
The downstream face of the “Barn Pond” dam consisted of tires stacked in a pyramid formation filled with native grasses similar to flower pots as well as scrap metal including bed springs, sheet metal and vehicle parts. These additions indicate the pond was constructed by man and enhanced by beavers.

Figure 19. Photos of scrap buried in the downstream embankment of the Barn Pond.
