## Memorandum

From: Rachel A. Zancanella, P.E., Division 2 Engineer

Subject: Bartlett Gulch, Twin Lakes Ditch Drainage, and Barn Pond Site Visit Determination  
July 9, 2024 Site Visit

Date: August 5, 2024

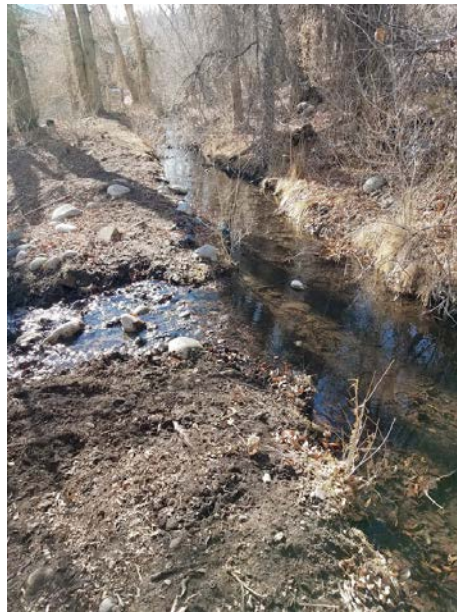
When the flow in a ditch segment that is not perpendicular to contour lines exceeds the ditch capacity, the water will over top and cut new channels that are perpendicular to contour lines (see Figure 4). In contrast, when a natural stream is dammed, water will flow around the obstruction and back into the natural channel downstream.

Figure 4. Example of Ditch Bank Breach

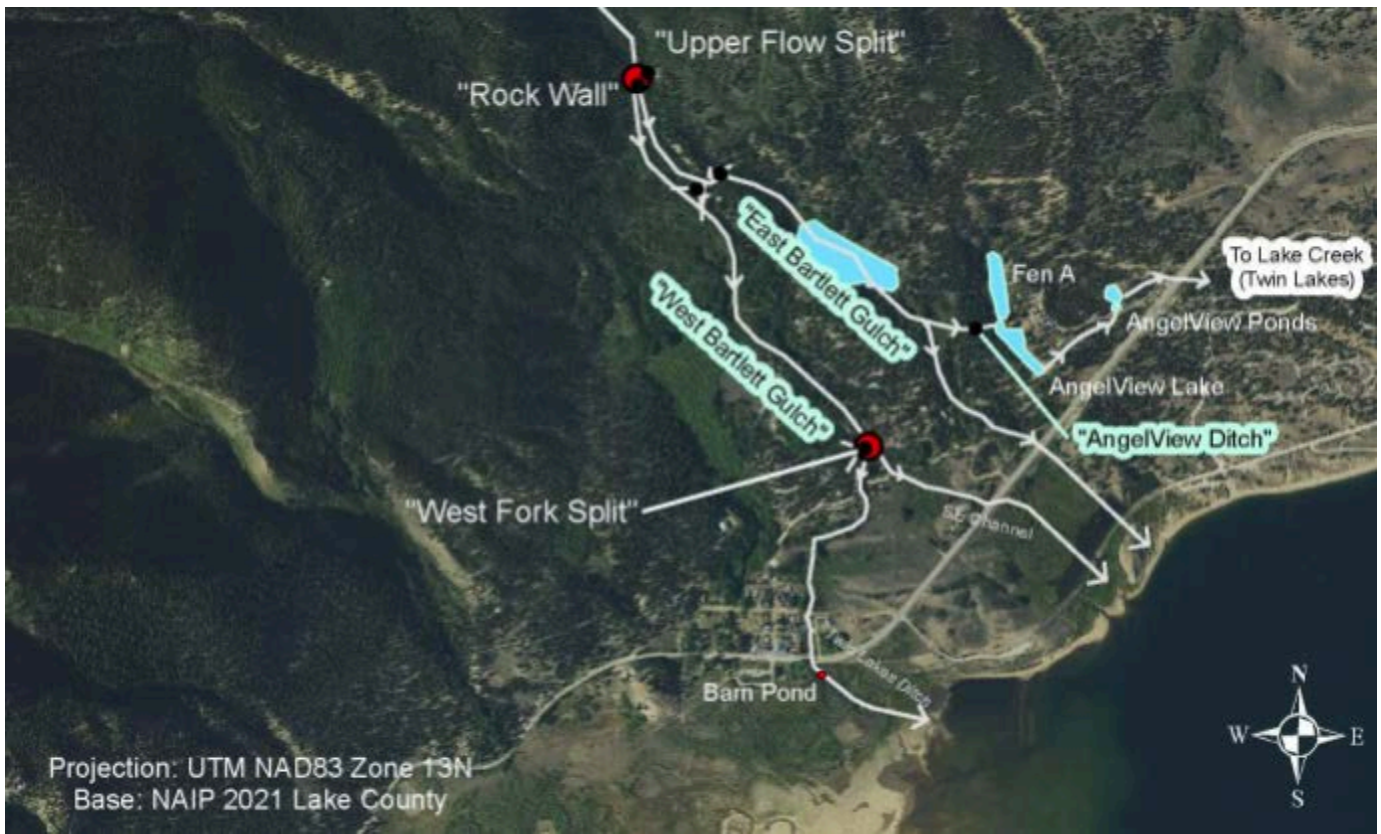
The drainage on Figure 5 labeled “Twin Lakes Ditch” was inspected from the split off of West Bartlett Gulch labeled “West Fork Split” in a southerly direction to the Barn Pond (see enlarged area in Figure 6). The numbered points/areas in Figure 6 correspond to a pictorial log of observations of the physical attributes of the channel as it runs through the Town of Twin Lakes. These areas are described in further detail below.

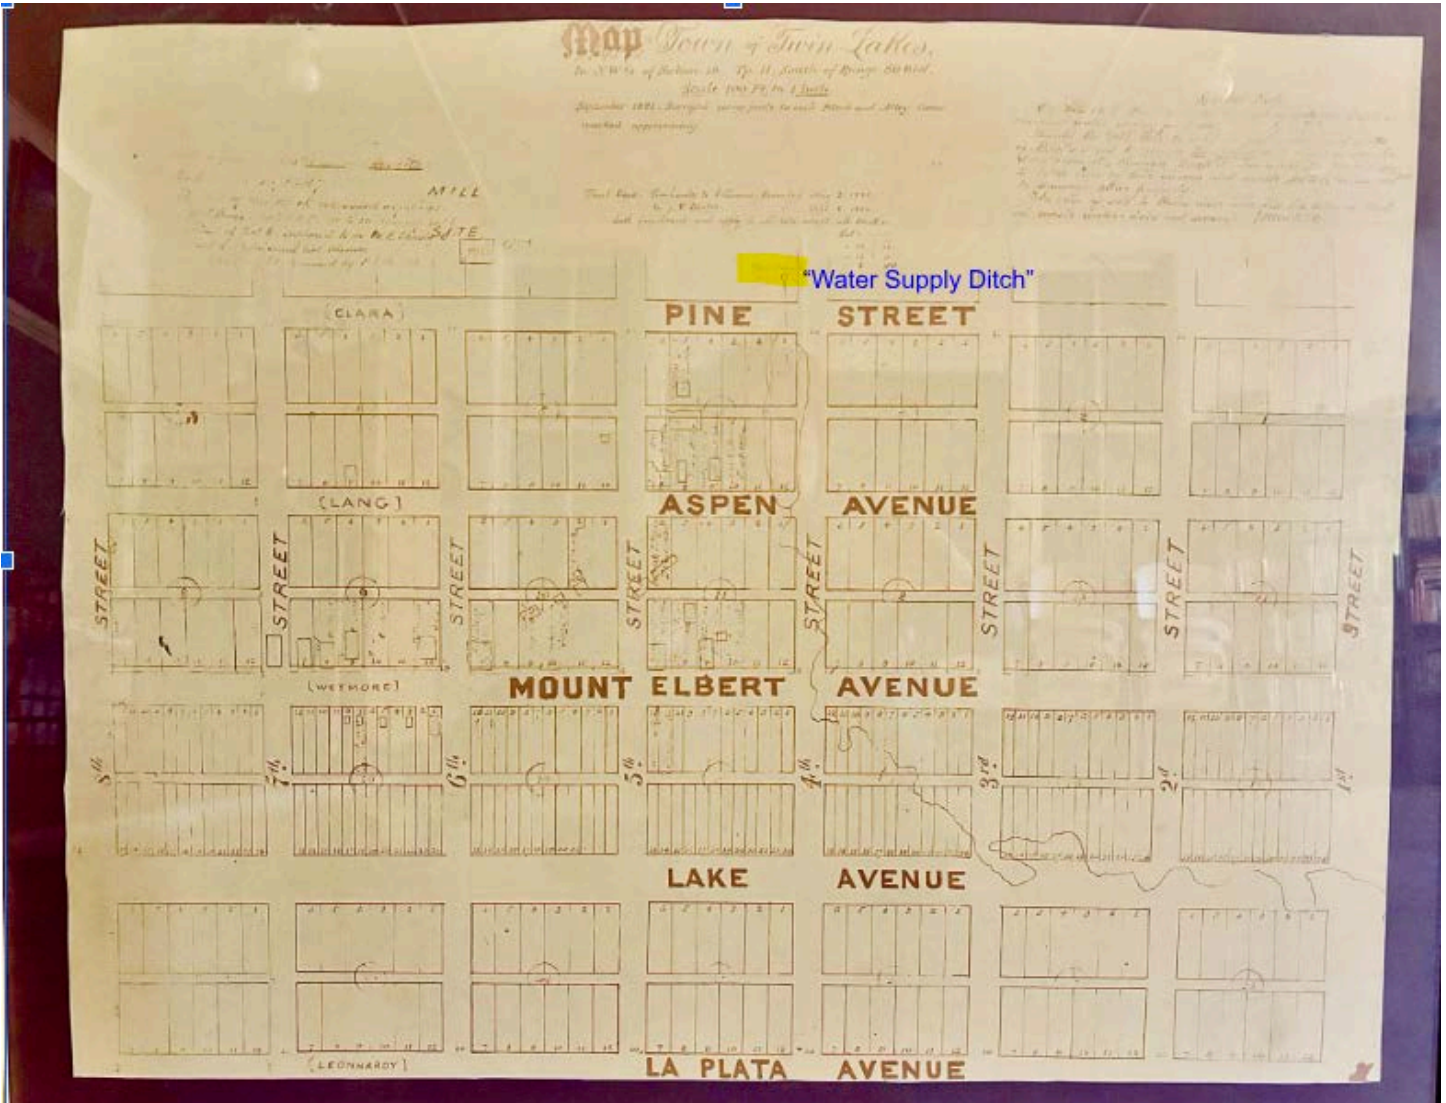
Figure 20 is the September 1891 plat map of the Town of Twin Lakes. Though difficult to observe when photographed behind glass, the text on the map in the highlighted area is legible in person on the original map housed in the School House - It states "Water Supply Ditch". The mapped Water Supply Ditch generally follows the current path of Twin Lakes Ditch: down 4th Street and then east down Lake Avenue. During our field visit, it was represented that Mr. Marcum's beaver dam pond had been in existence since the 1900's. We assume this statement was based on it being located in the same area as the "reservoir" (between Pine Street and Aspen Avenue). It should be noted that it was not common practice to note "beaver dams" on plat maps in this era nor have we ever seen them noted on map and filing statements, probably due to their transient nature. However, it was common to note ditches and reservoirs. Finally, the windmill on Marcum's property (Figure 21) is also a hand dug well with hand laid stones common of wells that pre-date the 1950's. It is located in close proximity to the "water supply ditch". It may have been constructed as part of the proposed town water supply system as either a primary or secondary source.

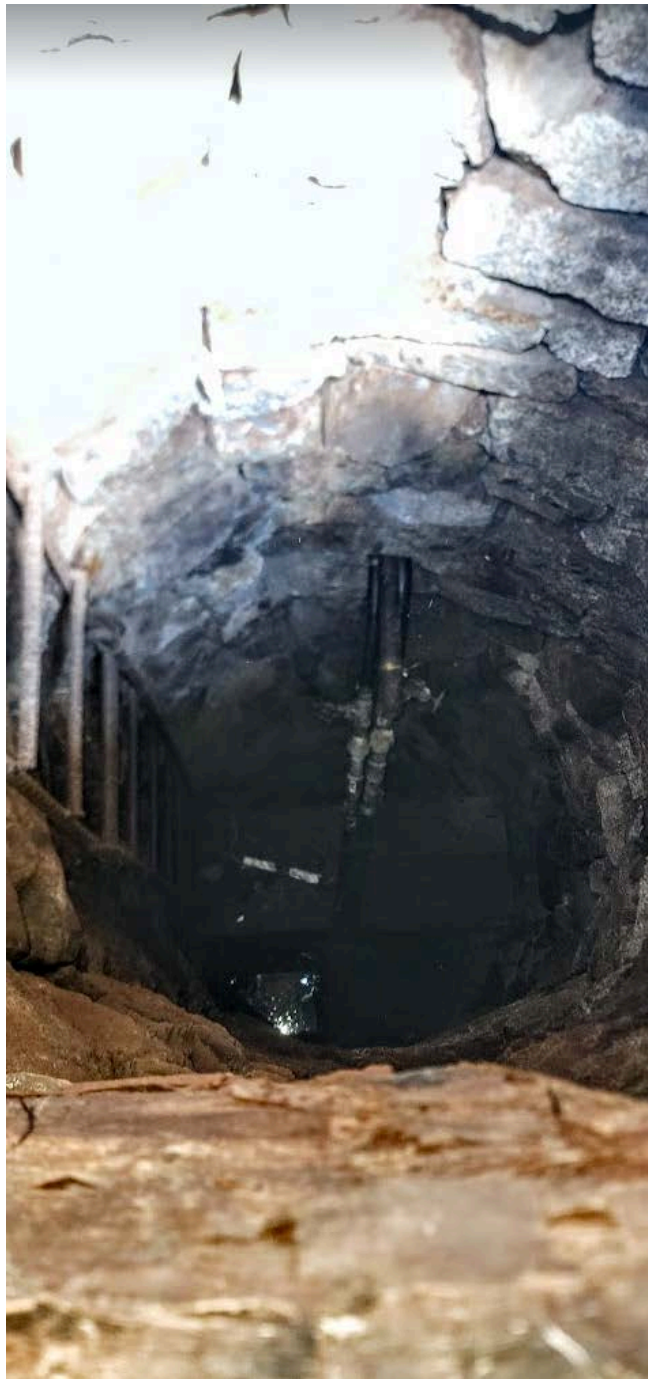
Figure 21. Windmill Well

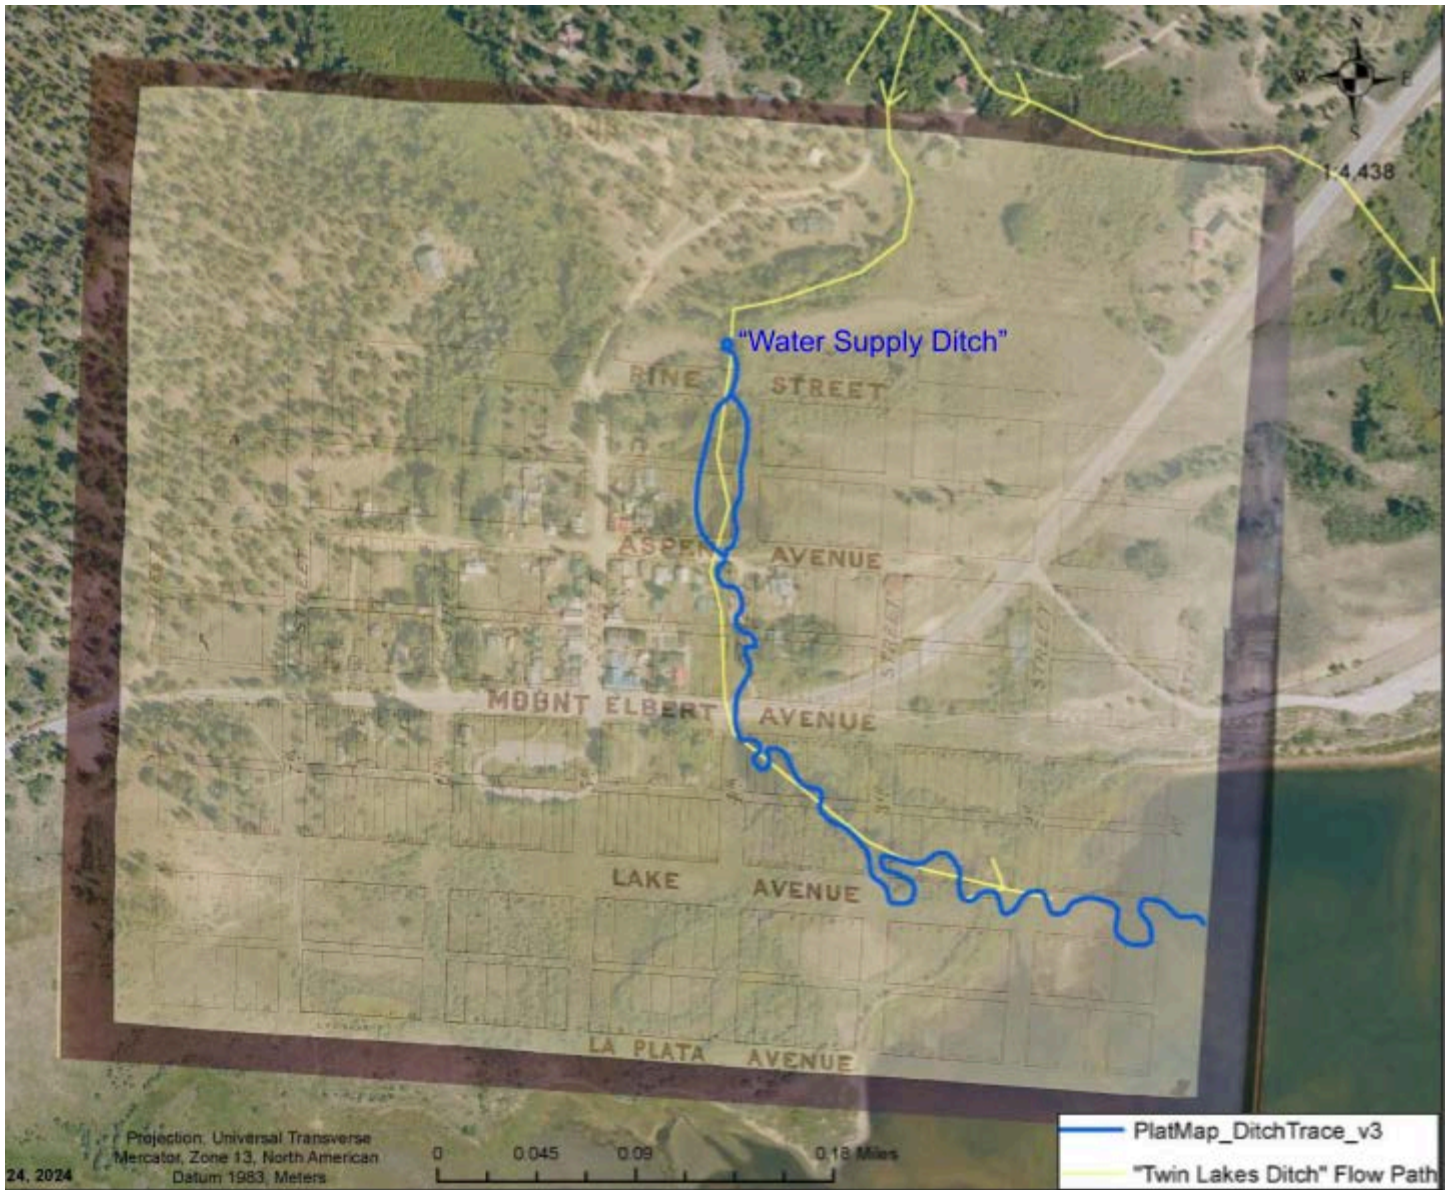
Figure 22 and Figure 23 are the Town of Twin Lakes Plat map overlaid on an aerial photo with the Water Supply Ditch digitized in blue. In our observations, it is not uncommon to find beaver dams built on top of existing and abandoned man made structures, such as the reservoir shown on the plat map.

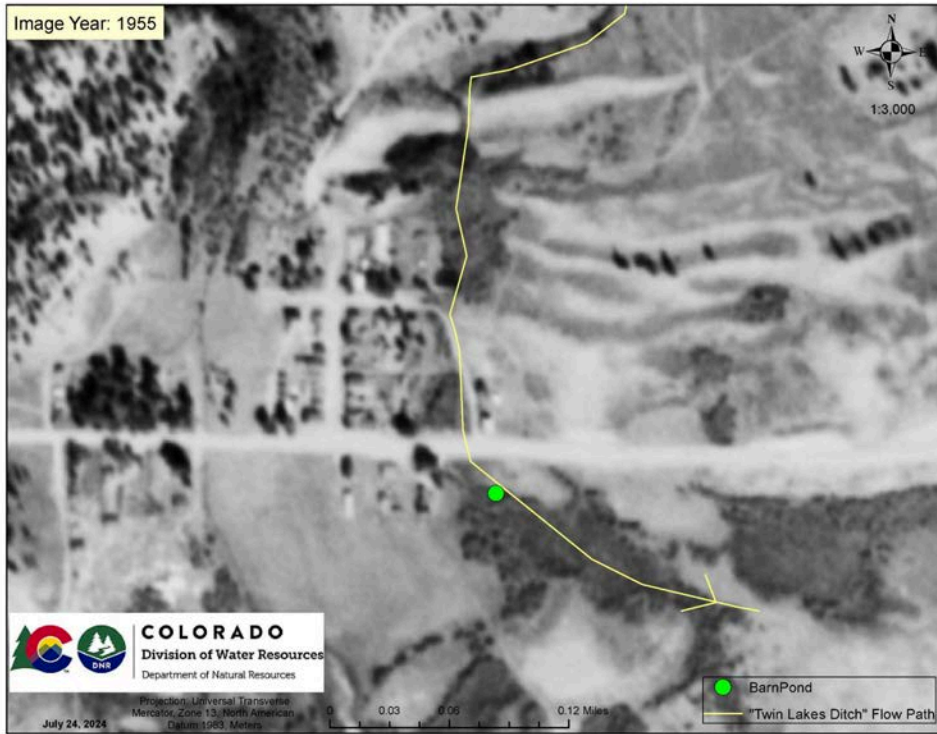
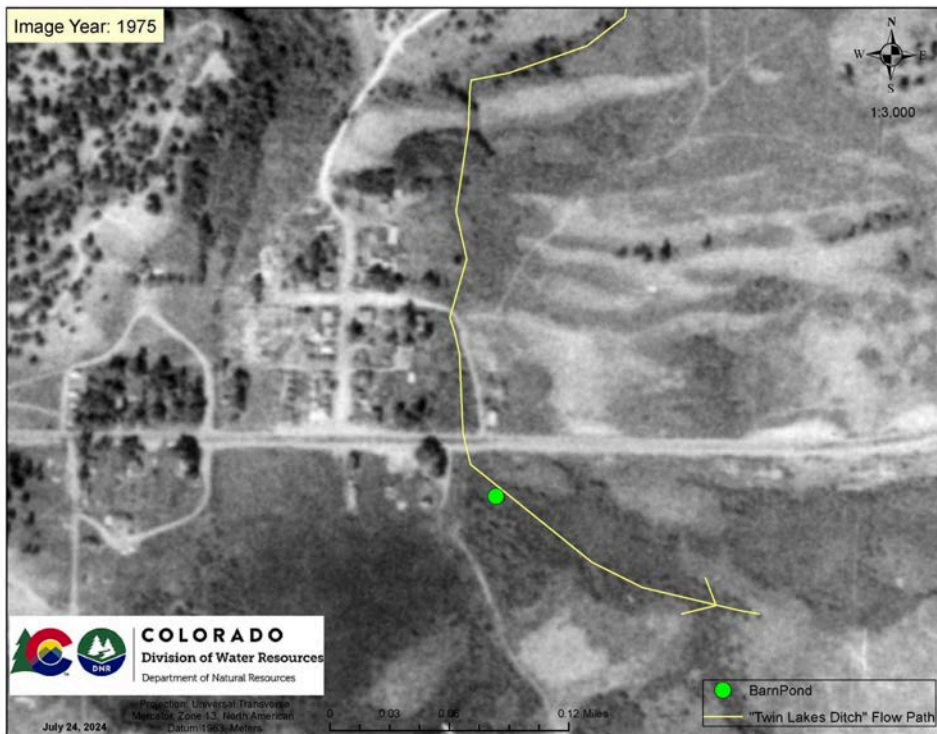
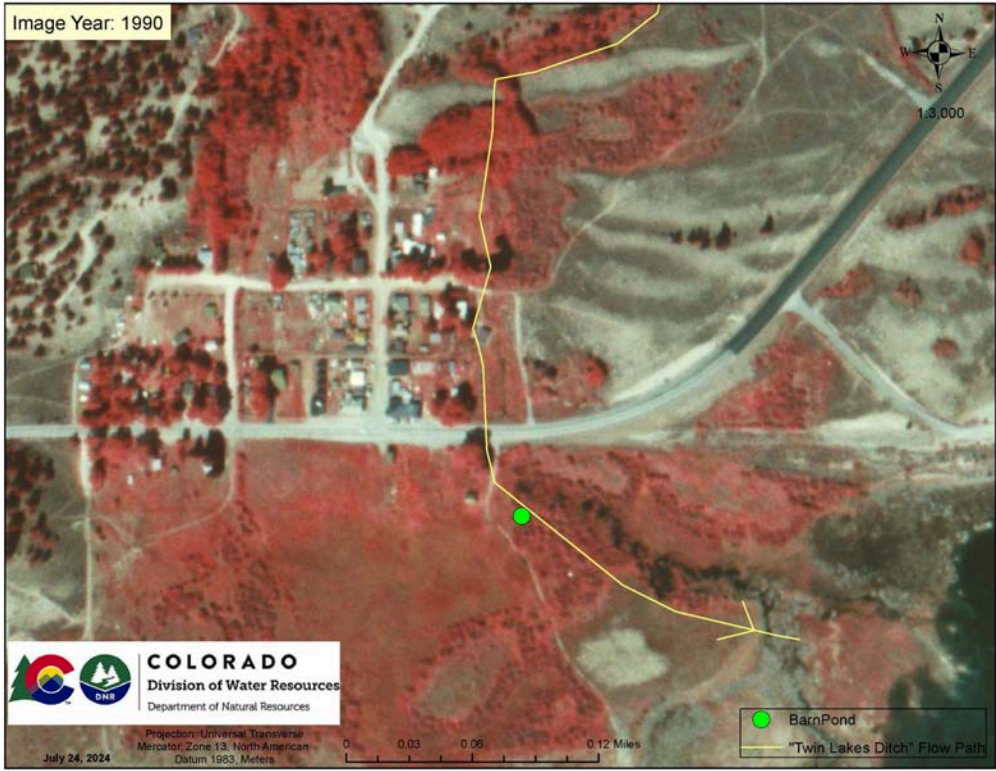
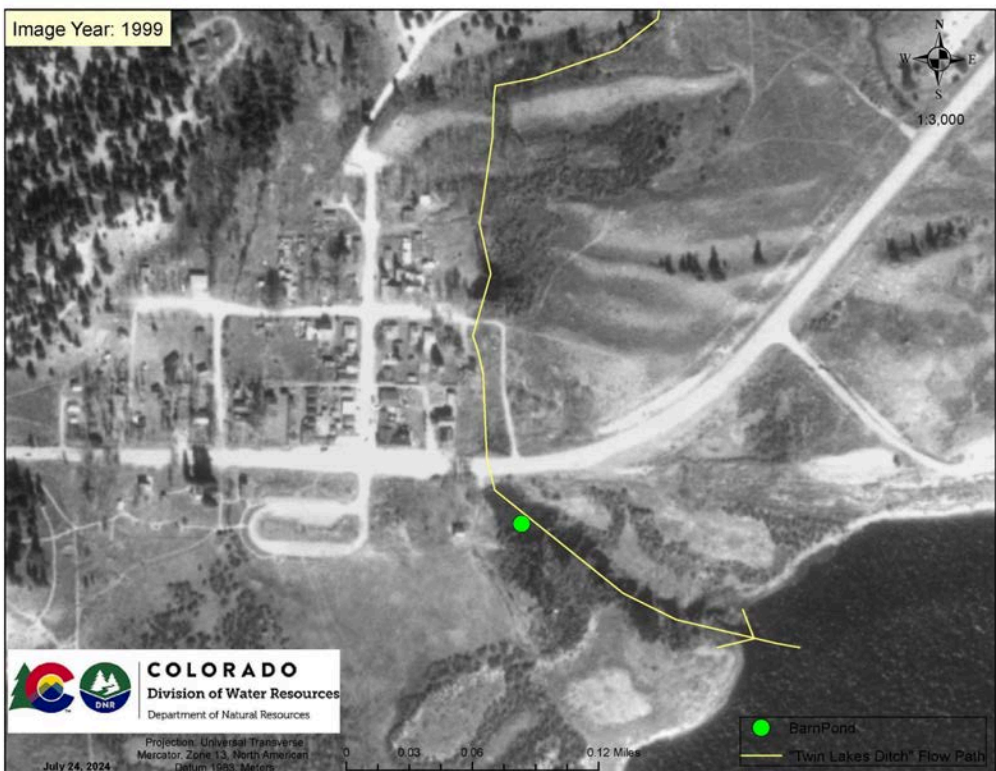
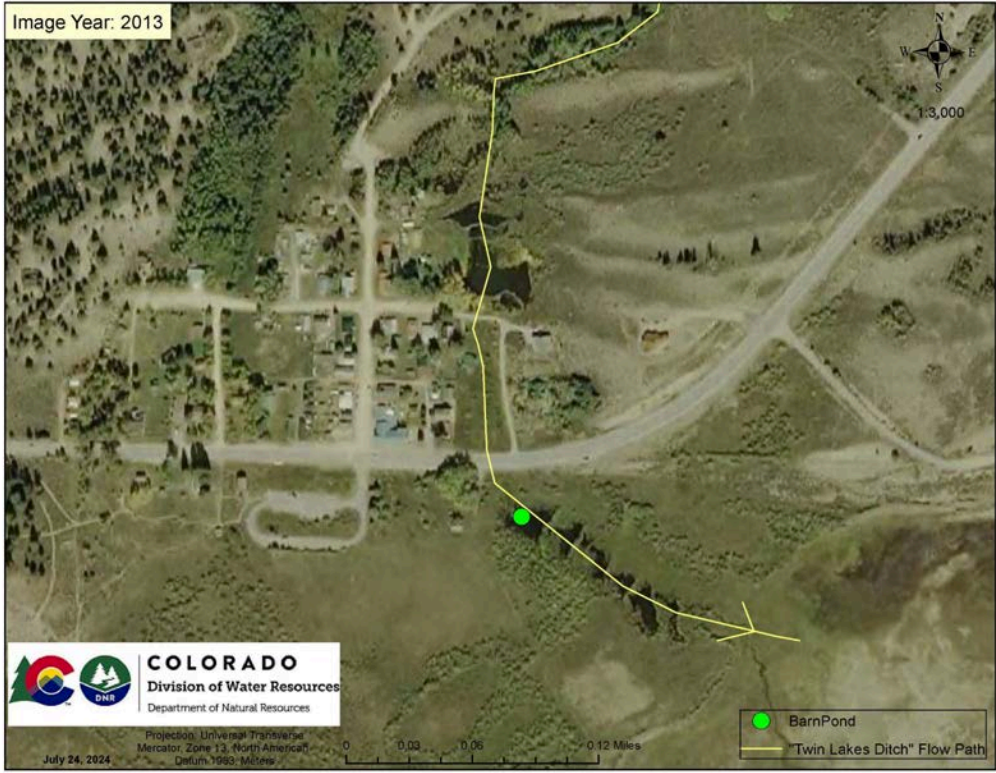
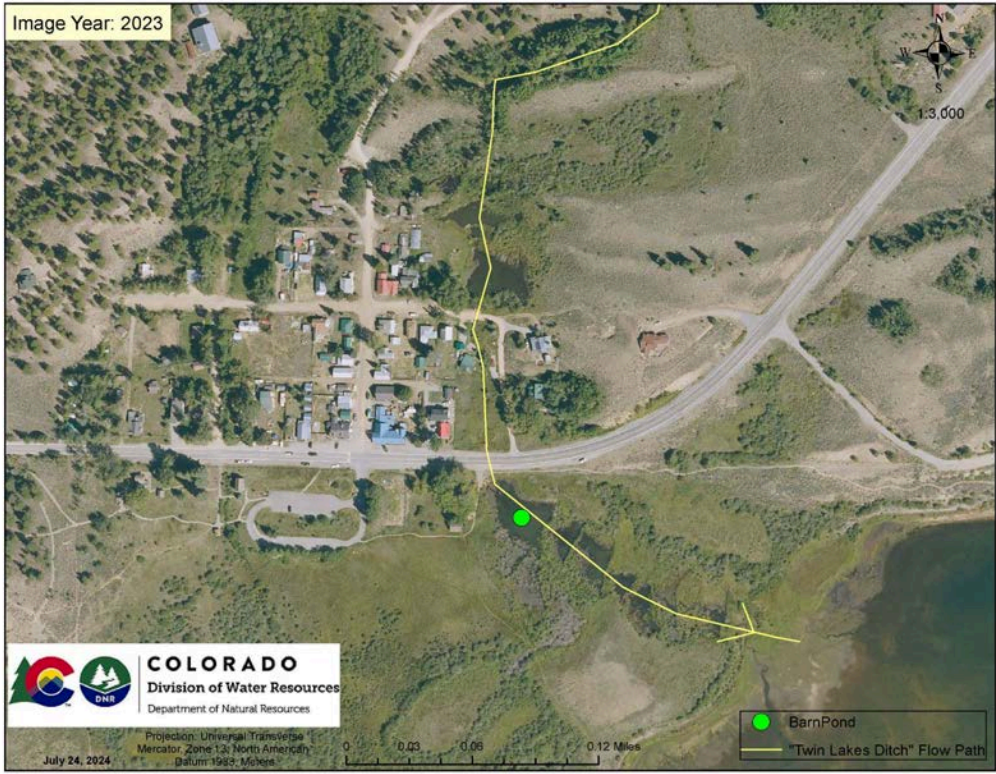
The following section reviews available aerial photography of the area from 1955-2023 of Marcum's Beaver Ponds down to the Barn Pond. The Barn Pond was a wet area in the 1955 and earlier photos, but a visible pond did not appear until between the years 1990 to 1999.
